Manhole Inspection Summary

Manhole # S07GG2012MH

Insp Date: **7/6/06 9:20 AM**

Location Address: **6202 PIMILICO RD**

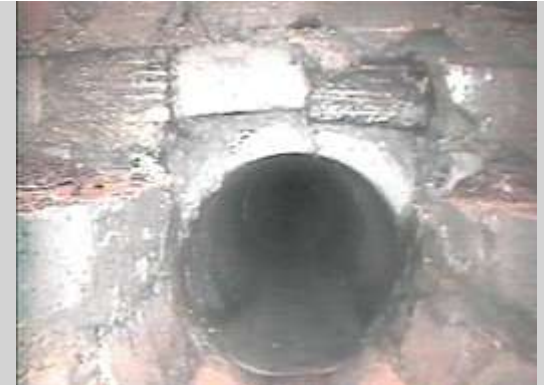
8 in. Circular Gravity Sewer Pipe Out @ 12 O'Clock

Pipe Material: **Clay** ☐ Pipe Lined

Invert Depth: **8.30** (ft.) Flow Characteristics: **Slow**

Deposits: ☒ None ☐ Mud ☐ Sludge ☐ Debris ☐ Grease

Infiltration: **None** Pipe Seal Cond: **Unknown**

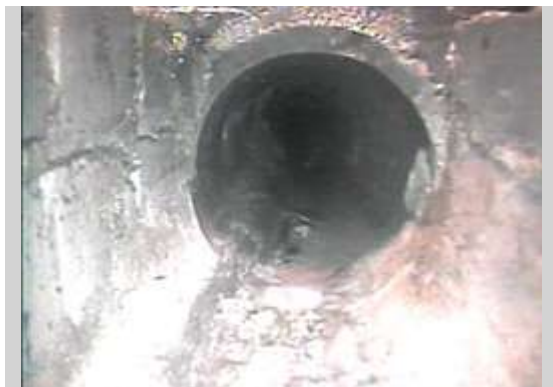
6 in. Circular Gravity Sewer

Pipe Material: **Clay**

Infiltration: **None**
